Turbo HD DVR V4.26.010 build 200923 Release Notes (2020-10-18)

Firmware Basic Information	Firmware Version:	V4.26.010 build 200923
	SDK Version::	V6.1.4.20 build 20200320
	Onvif:	V2.2
	Player:	4.810mini
	Player library:	7.3.8.49
	Web version:	V4.0.1 build 20200822
	Client version:	V2.6.13.0 build 20181115

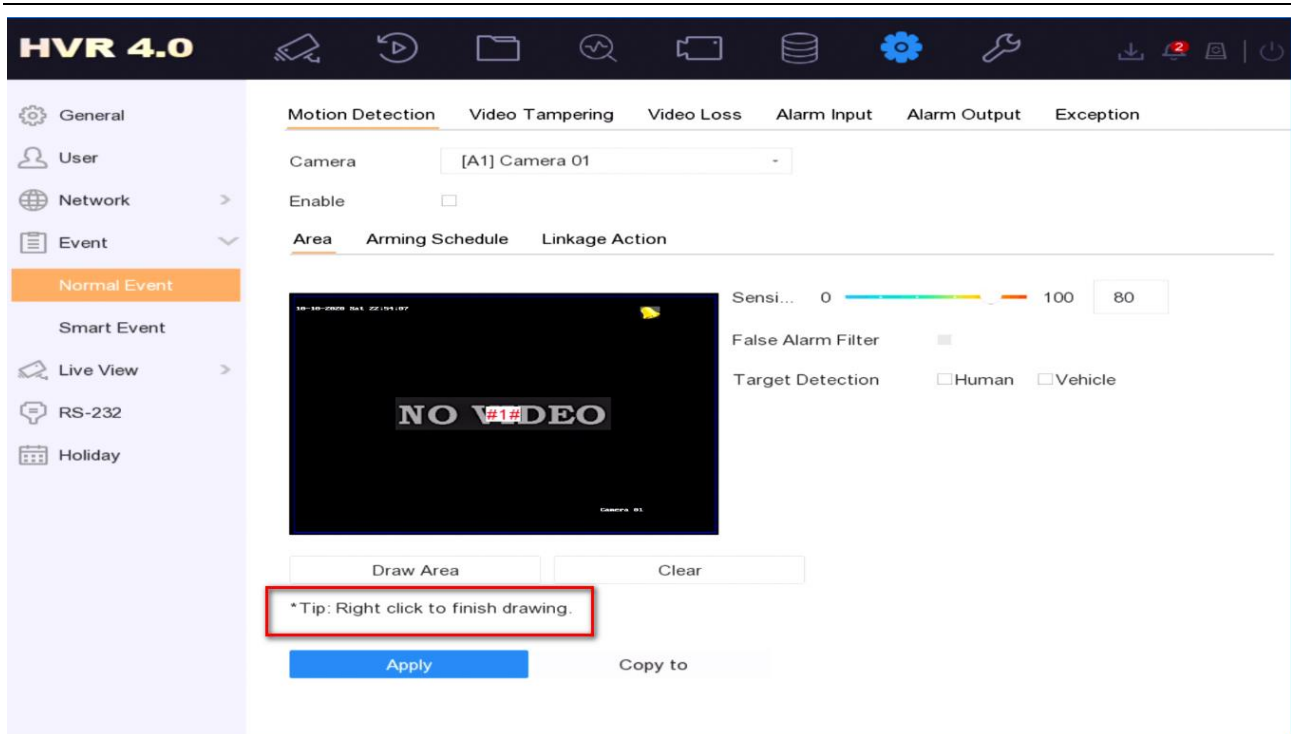
1. Supports sending customized voice to front-end analog camera through Hik-connect, and supports linkage of front-end customized voice playback in case of alarm.
2. Integrated audio noise reduction algorithm with native player library.
3. The analog channels of 4-ch HUH-M device support accessing 8MP camera, the analog channel 1 remains the same as the original (live view and coding configuration, etc.), the analog channels 2-4 access 8MP camera, local live view will be 8MP@15 and adopt 8MPlite code (1920*2160) , and smart code is not supported after access to 8MP.
4. For advanced motion detection, a tip is added below the drawing button in the interface of "System - Event – Normal Event - Motion Detection": "Tip: Right click to finish drawing".
